RUBICON MANUFACTURING INC. 3290 MONIER CIR., RANCHO CORDOVA, CA. 95742 916-473-4600

## INSTALLATION INSTRUCTIONS FOR: RE8530 2" WJ BUDGET BOOST SUSPENSION LIFT

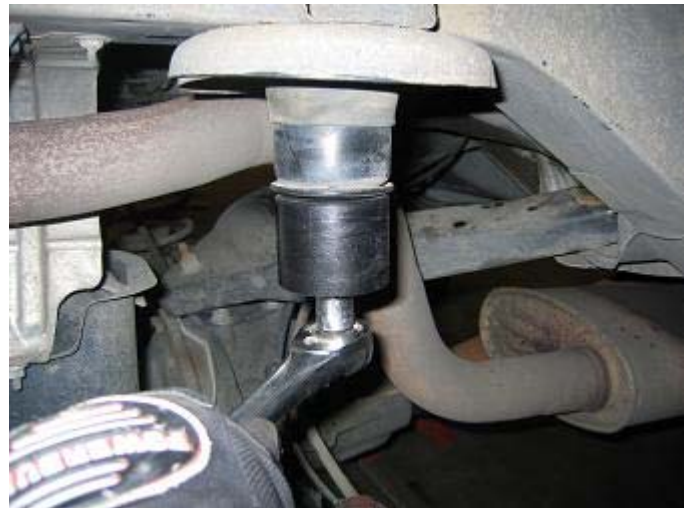
PHOTO 1

1. Support the vehicle chassis, axle housing, and remove rear wheels.
2. Remove old shocks.
3. Disconnect rear sway bar end links.
4. Lower rear axle assembly and remove rear factory coils.
5. Install RE1393 rear bump spacers on to the factory coil locating extension using the supplied self-taping hardware. (See photo 1)
6. Install coil spring spacers with radius side down (see photo 2).
7. Install rear coil springs.
8. Raise the axle housing and reconnect rear sway bar end links.

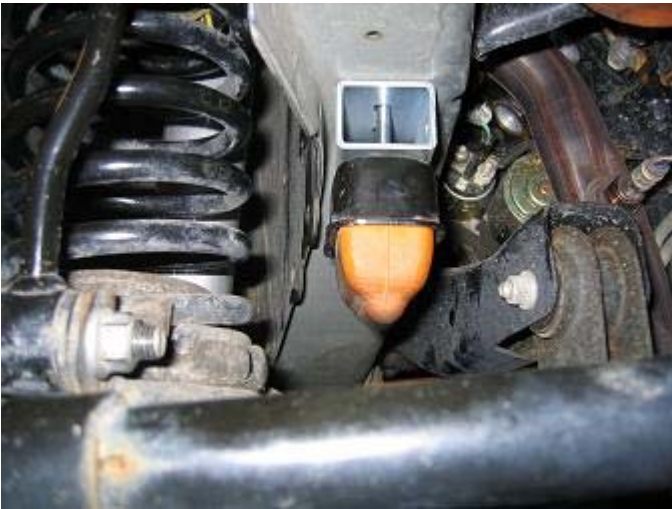
PHOTO 3

15. Reinstall the cups with the RE1392 extensions between the frame rail and the cup using the supplied longer hardware.
16. Reinstall the factory rubber bump stop. (See photo 3)

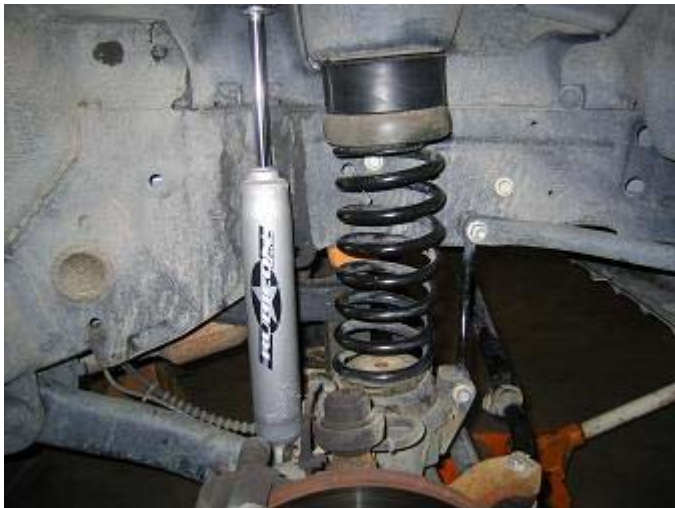
Photo 4

17. Lower front axle assembly and remove front factory coils.
18. Remove rubber coil spring isolators.
19. Install coil spring spacer between frame and rubber spring isolator with lip down (see photo 4).
